## Annexure -2

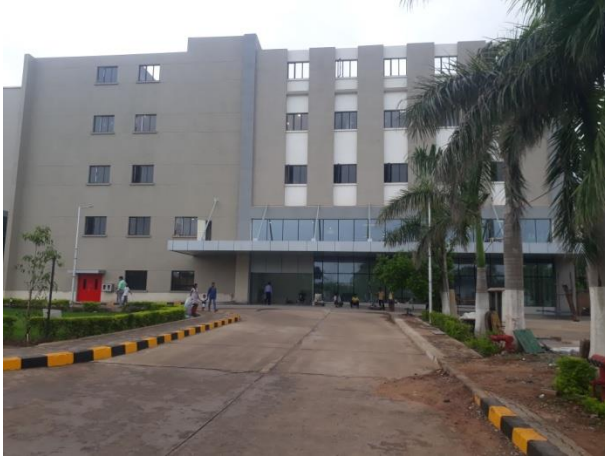
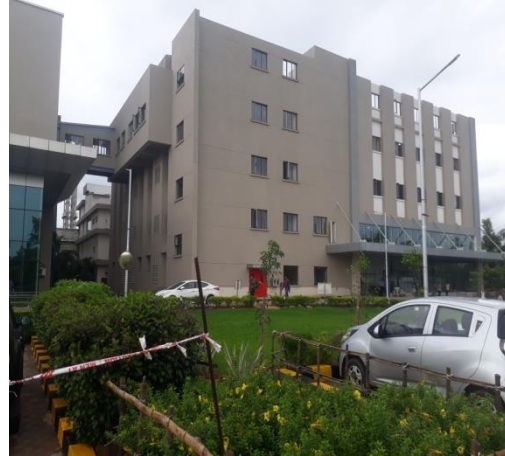
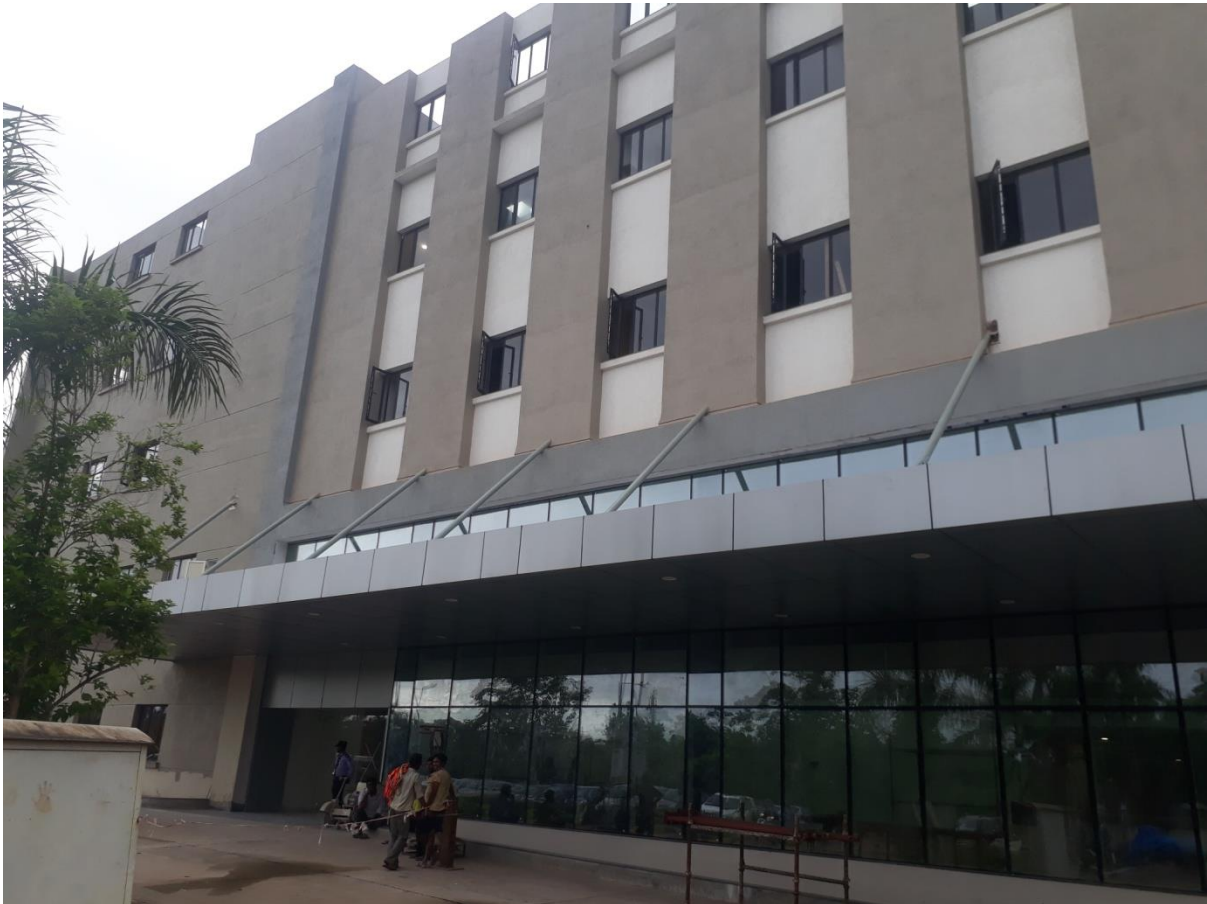
Construction work outer work complete plaster and painting work complete and inside and outer side window and door we fixed so that we remove Strong barricade form construction side.
